## dsPIC30F4011/4012 Rev. A1 Silicon Errata

### dsPIC30F4011/4012 (Rev. A1) Silicon Errata

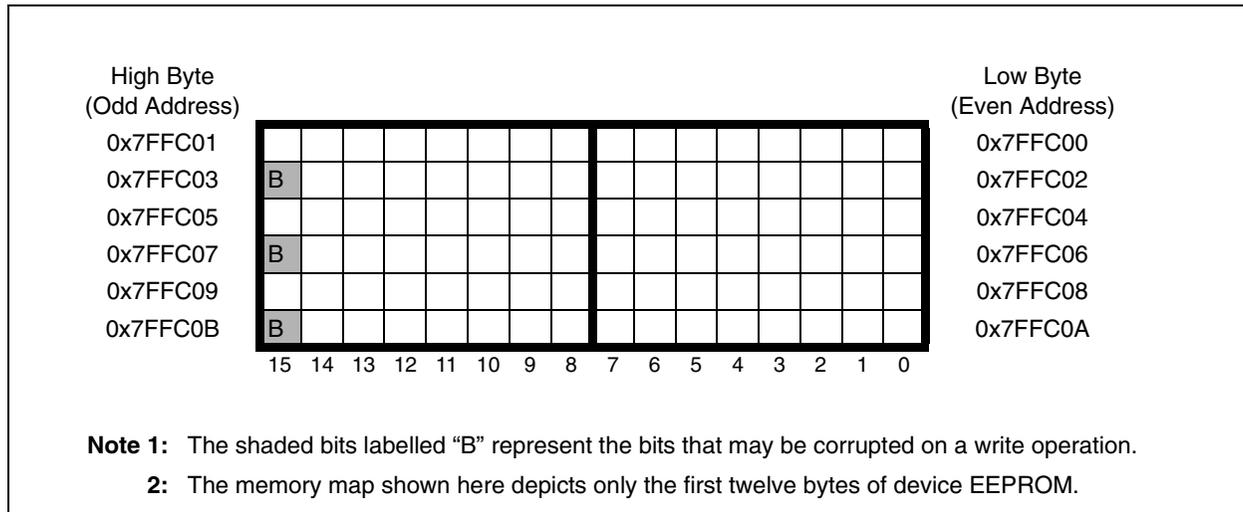
**FIGURE 1: dsPIC30F4011/4012 DATA EEPROM**

The Most Significant bit of every fourth byte in data EEPROM may be corrupted on any write operation. This write corruption may occur while using either PRO MATE<sup>®</sup>, MPLAB ICD 2 or Run-Time Self-Programming (RTSP).

Figure 1 shows the first twelve bytes in data EEPROM and indicates the affected bits.

Use program Flash memory instead of data EEPROM to store constant data.

Use less than 16 bits in each word in the available word of data EEPROM, excluding the Most Significant bit.

Avoid using every fourth byte. Example 1 shows how the ASM30 assembler can be used to allocate data in the EEPROM under this constraint.
