Intel[®] 80314 I/O Processor Companion Chip

Specification Update

| *July 2004*

Order Number: 273759-006

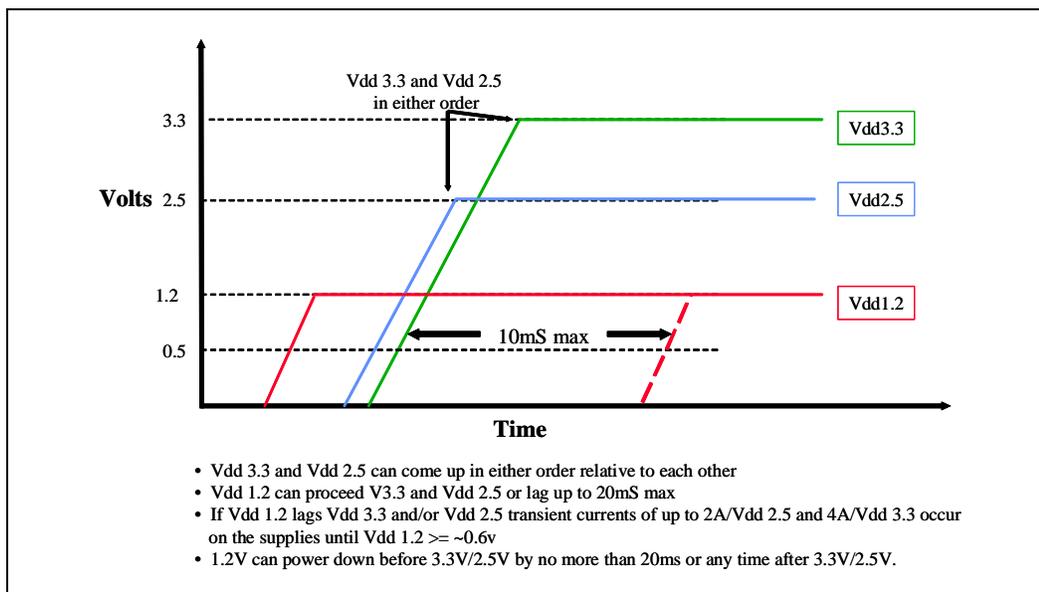
Figure 1. Power-Sequencing Requirements

Issue: The power-up and power-down sequences of the 80314 1.2 V/2.5 V/3.3 V supply rails has been revised from version 003 and 004 of this specification update. The power sequencing requirements initially presented in version 003 were designed to avoid transient current draw that could appear on the 2.5 V/3.3 V supply rails. Further investigation has determined that no current transients occur when the 1.2 V supply is ramped first. In addition, it is acceptable to ramp the 1.2 V supply after the 2.5 V and 3.3 V supplies as long as the lag is less than or equal to 20 mS. When the 1.2 V rail lags the 2.5 V and/or 3.3 V rail, transient currents of up to 2 A/V_{DD2.5} and 4 A/V_{DD3.3} can occur on the supplies until V_{DD1.2} >= ~0.6 V. The 1.2 V supply can power down no more than 20 ms before or any time after the 3.3 V/2.5 V supplies power down. These requirements are illustrated in Figure 1.
