MICROCHIP PIC18F2410/2510/4410/4510

PIC18F2410/2510/4410/4510 Rev. B4 Silicon Errata

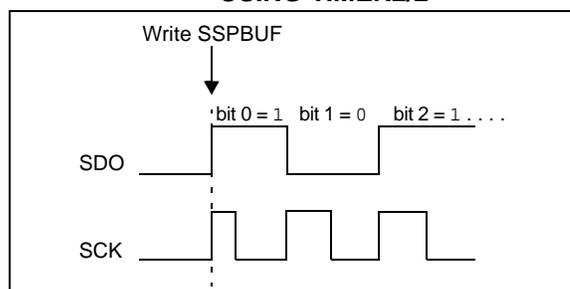
FIGURE 1: SCK PULSE VARIATION USING TIMER2/2

When the SPI is using Timer2/2 as the clock source, a shorter than expected SCK pulse may occur on the first bit of the transmitted/received data (Figure 1).

To avoid producing the short pulse, turn off Timer2 and clear the TMR2 register, load the SSPBUF with the data to transmit and then turn Timer2 back on. Refer to Example 1 for sample code.
