## MSP430F5419A Device Erratasheet

### 1 Revision History

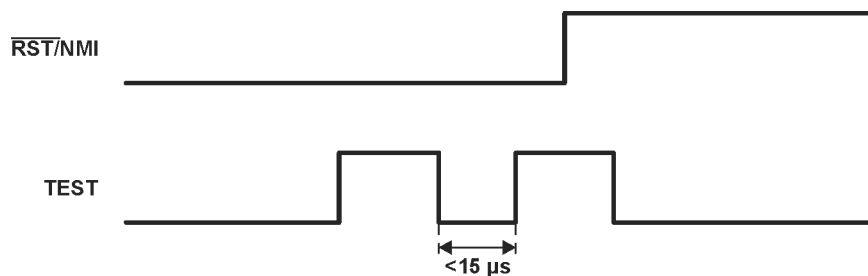
The BSL entry sequence requires that the low phase of the TEST/SBWTCK pin does not exceed 15us. This timing requirement is faster than most PC serial ports can provide, as shown in the following picture. If this requirement is not met, the entry sequence fails and the SYSBSLIND is not set.

An external hardware solution is recommended to provide the appropriate BSL entry sequence. See [http://processors.wiki.ti.com/index.php/BSL\\_\(MSP430\)](http://processors.wiki.ti.com/index.php/BSL_(MSP430)) for recommendations on available BSL hardware.
