## MSP430F5632 Device Erratasheet

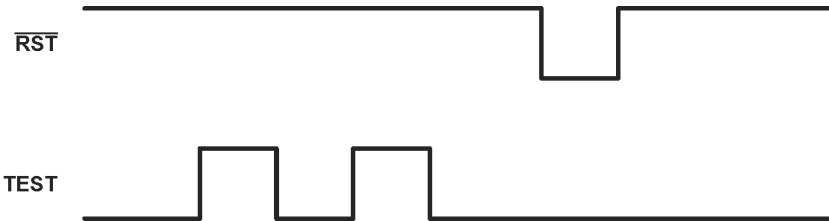
<b>JTAG20</b>	<b><i>JTAG Module</i></b>
<b>Function</b>	BSL does not exit to application code
<b>Description</b>	The methods used to exit the BSL per MSP430 Programming Via the Bootstrap Loader ( <a href="#">SLAU319</a> ) are invalid.
<b>Workaround</b>	<p>To exit the BSL one of the following methods must be used.</p> <ul style="list-style-type: none"> <li>- A Power cycle</li> <li>or</li> <li>- Toggle the TEST pin twice when nRST is high and then pull nRST low.</li> </ul>
