## Stellaris® LM3S2678 RevA0 Errata

This document contains known errata at the time of publication for the Stellaris LM3S2678 microcontroller. The table below summarizes the errata and lists the affected revisions. See the data sheet for more details.

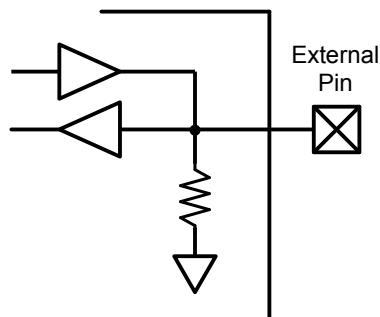
**Figure 1. Internal Structure of PB0 and PB1**

Regardless of their configuration, PB0 and PB1 have an internal pull-down resistance. The internal structure of these pins is shown in Figure 1 on page 8.

When either of these pins is configured as an input, the external circuit must provide enough drive strength to over-drive the internal pull-down and achieve the necessary  $V_{IH}$  voltage level. If an external pull-up resistor is used, it must have a low value such as  $\sim 1\text{ K}\Omega$  or less for PB0 and  $\sim 50\text{ K}\Omega$  or less for PB1.

When either of these pins is configured as an output, the drive current needed to over-drive the internal pull-down resistance must be subtracted from the drive capabilities of the pin. In some applications, it may be necessary to select a higher drive strength (such as 4 mA instead of 2 mA) to achieve an acceptable output voltage on PB0.

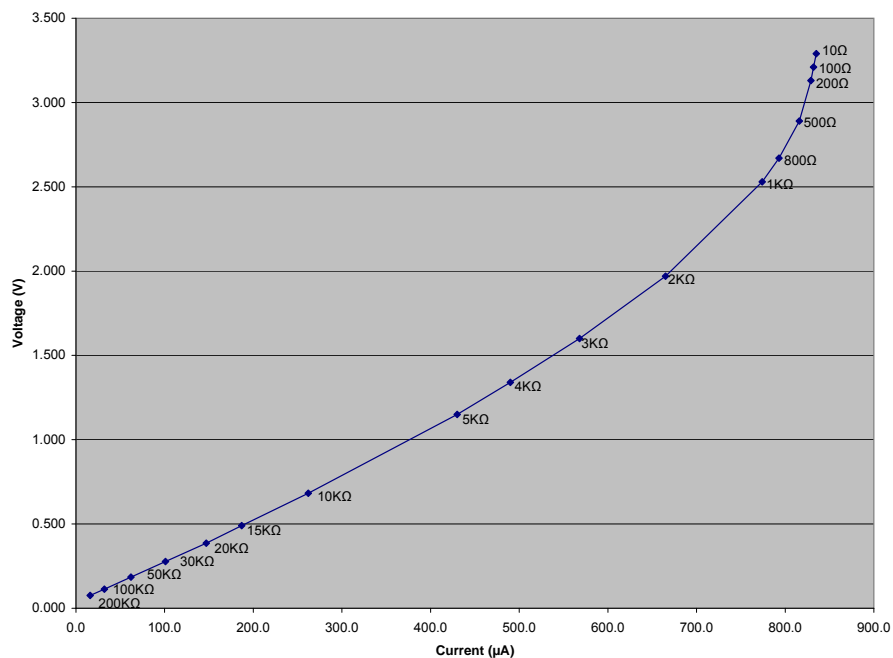
**Figure 2. Voltage vs. Current for Various External Pull-up Resistors on PB0**

The characteristic of the pull-down for PB0 is shown in Figure 2 on page 9. The data labels for each data point show the external pull-up resistance in Ohms.

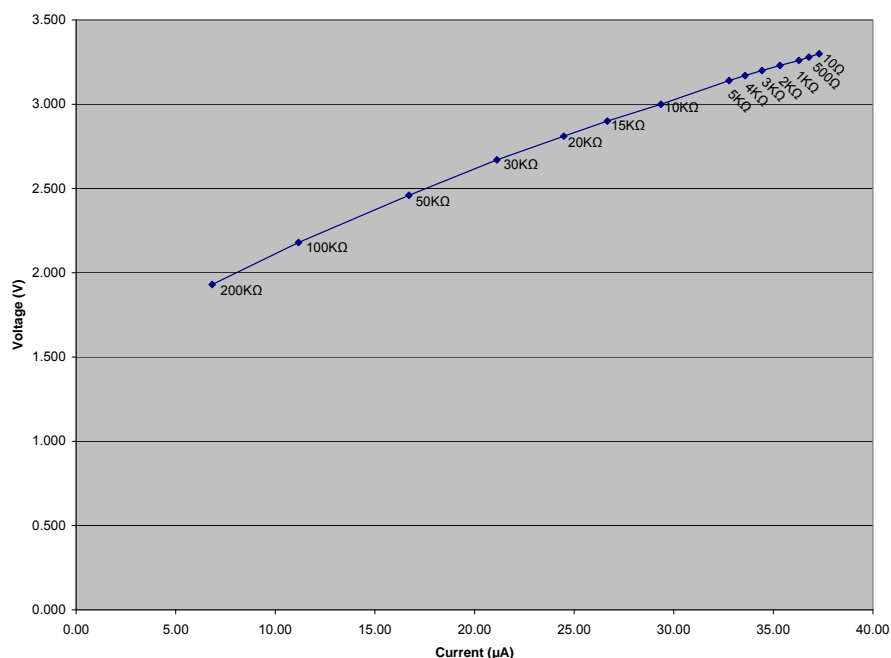
Figure 3. Voltage vs. Current for Various External Pull-up Resistors on PB1

The characteristic of the pull-down for PB1 is shown in Figure 3 on page 10. The data labels for each data point show the equivalent resistance in Ohms.
