# **AM3517/05 Sitara ARM Microprocessors Silicon Revisions 1.1, 1.0**

## **Errata**

Literature Number: SPRZ306D  
October 2009–Revised June 2012

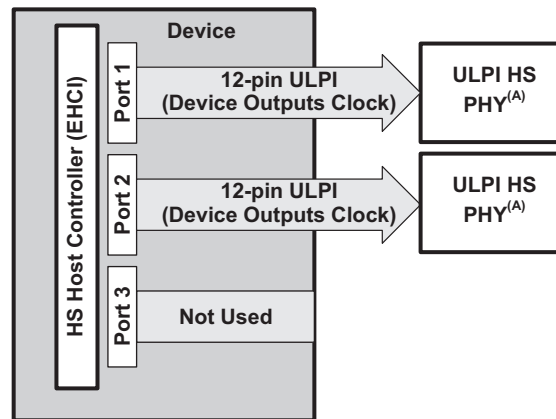
**Figure 4. Connecting to High-Speed PHYs Using USB Ports**

As shown in Figure 4, USB Port 1 and Port 2 can be used to connect to external high-speed PHYs which include a ULPI port. However, in this case, the external USB PHY must be able to accept a source clock generated by the high-speed USB controller. Also, in this usage model the USB ports cannot support full-speed and low-speed operation. Therefore, using this approach, USB Port 1 and Port 2 cannot provide a fully compliant USB 2.0 Type-A receptacle; a high-speed USB hub would be required in this case; please see Figure 5.

A. USB port 3 does not support ULPI mode.

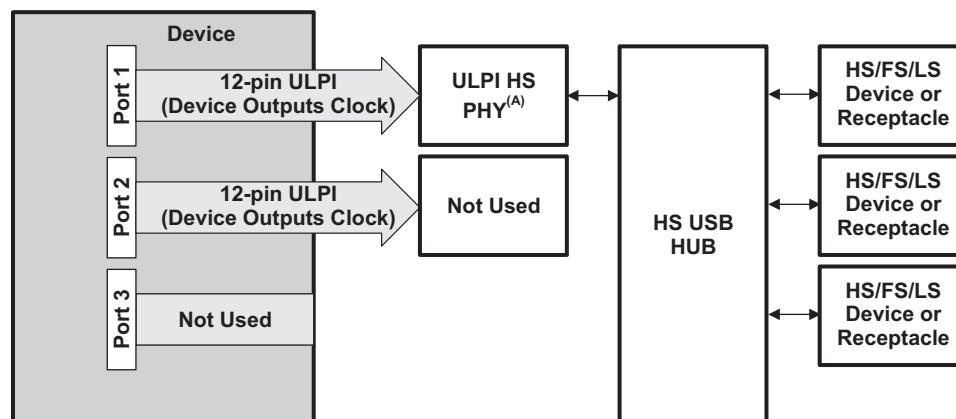
**Figure 5. Connecting to a High-Speed USB Hub**

A. USB port 3 does not support ULPI mode.

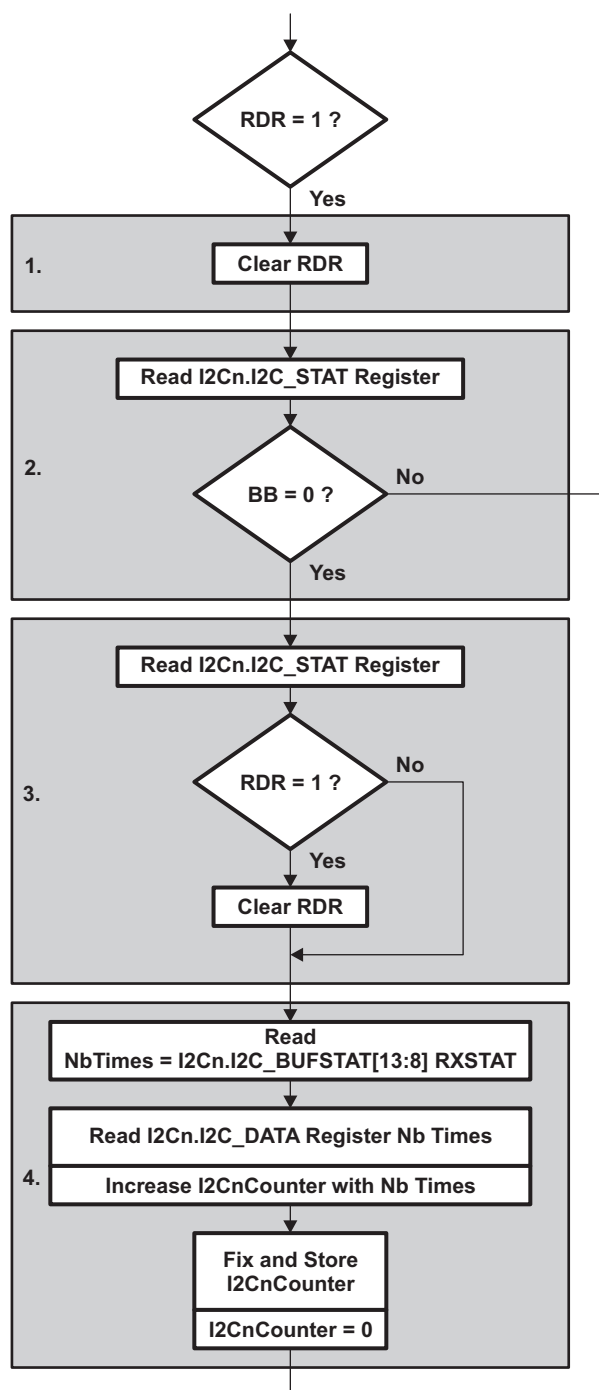
**Figure 6. I2C Flowchart**

**Details**      Under certain rare conditions, the I2C\_STAT[13].RDR bit may be set as well as the corresponding interrupt fire, even when there is no data in the receive FIFO, or the I2C data transfer is still ongoing. These spurious RDR events must be ignored by the software.

**Workaround(s)**      Software must filter out unexpected RDR pulses, using the flowchart illustrated in [Figure 6](#) when receiving an I2C RDR interrupt.

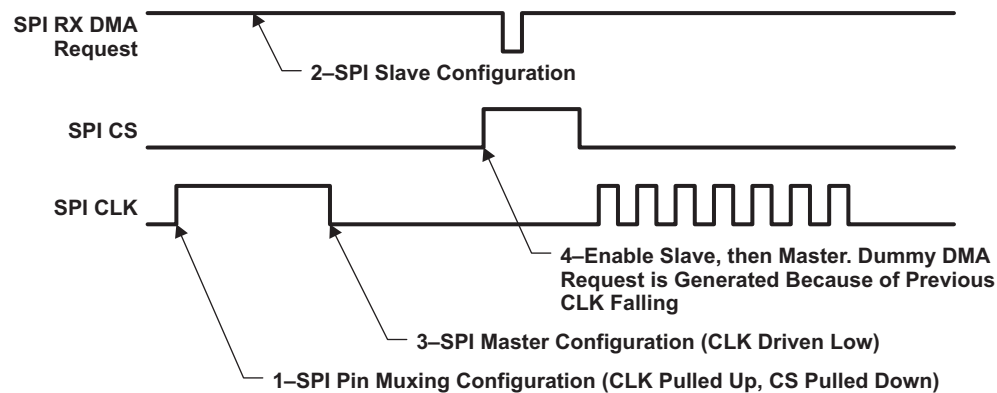
**Figure 7. SPI Dummy DMA RX Generation**

A dummy DMA RX request is generated as soon as the SPI is configured in *slave* mode and a SPI clock edge is detected. The dummy DMA RX request is generated during module configuration, when the module is not performing an SPI transfer. The dummy DMA RX request occurs as soon as the SPI interface signal sensitivity is changed compared to the default value.

The dummy DMA RX request is generated because the mechanism to avoid dummy data capture on a CS glitch is done regardless of channel activation.

**Workaround(s)** Avoid conditions where the SPI is in *slave* mode and the SPI clock toggles (see examples below).
