AM389x Sitara ARM Processors

Revisions 2.1, 2.0, 1.1, 1.0

Silicon Errata

Literature Number: SPRZ327F
November 2010—Revised April 2013

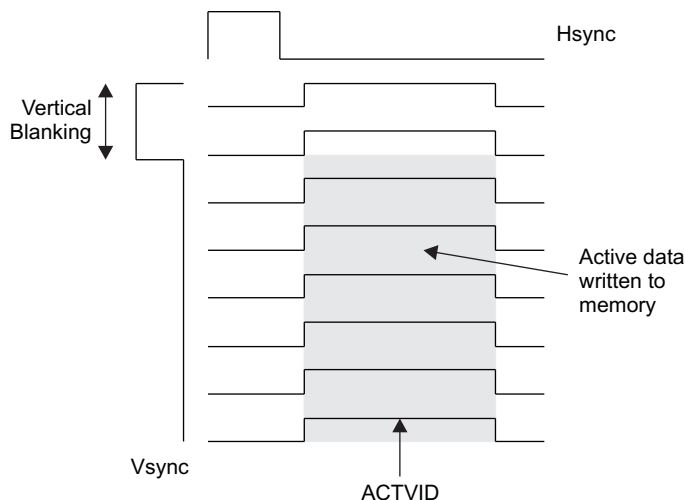
Figure 3. ACTVID Signal Active for All Lines of Incoming Data

Details: The VIP port supports a discrete sync capture mode where the ACTVID signal is used to determine the active region of the video and then the VPDMA writes this active video frame to memory. However, with some external video decoders, this mode does not work by default.

Workaround: The VIP parser requires that the ACTVID signal is active for all lines of the incoming data, including the vertical blanking region. The vertical blanking region, itself, is not written to memory by the VPDMA. [Figure 3](#) illustrates this.

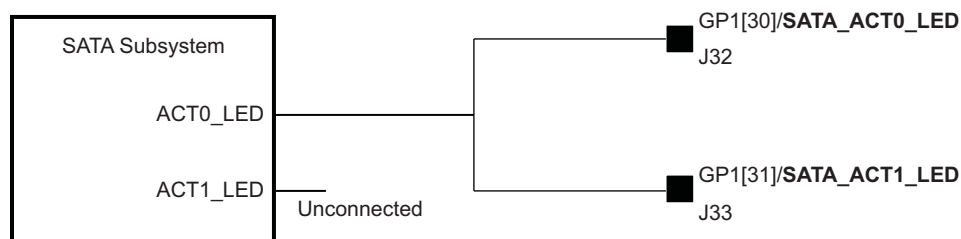
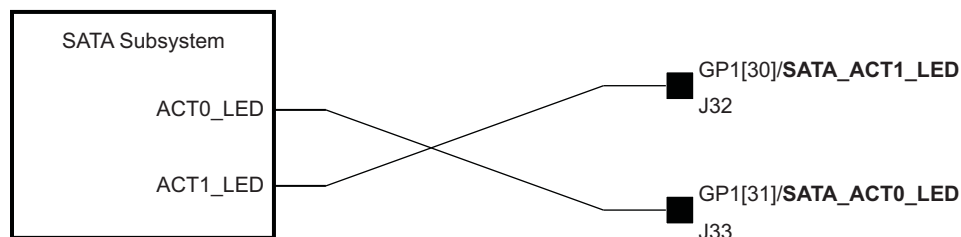
Figure 4. SATA Activity LED Connectivity

This issue is corrected on revision 2.0, but with the output pins reversed. SATA_ACT1_LED is mapped to pin J32 and SATA_ACT0_LED to pin J33 (see [Figure 4](#)).
