PIC18F24K20/25K20/44K20/45K20

PIC18F24K20/25K20/44K20/45K20 Silicon Errata and Data Sheet Clarification

The PIC18F24K20/25K20/44K20/45K20 devices that you have received conform functionally to the current Device Data Sheet (DS41303G), except for the anomalies described in this document.

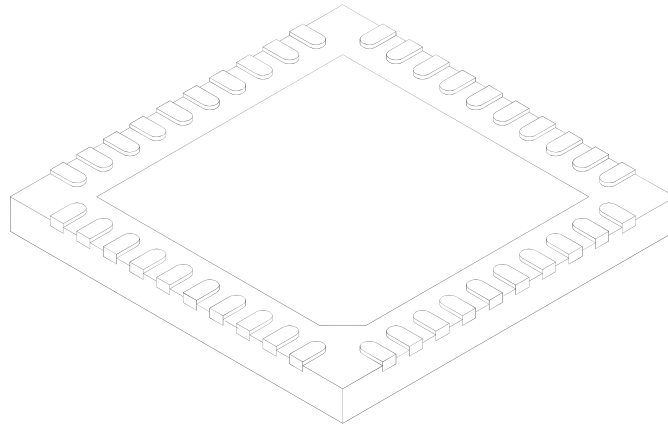
40-Lead Ultra Thin Plastic Quad Flat, No Lead Package (MV) – 5x5x0.5 mm Body [UQFN]

Units		MILLIMETERS		
Dimension Limits		MIN	NOM	MAX
Number of Pins	N	40		
Pitch	e	0.40 BSC		
Overall Height	A	0.45	0.50	0.55
Standoff	A1	0.00	0.02	0.05
Contact Thickness	A3	0.127 REF		
Overall Width	E	5.00 BSC		
Exposed Pad Width	E2	3.60	3.70	3.80
Overall Length	D	5.00 BSC		
Exposed Pad Length	D2	3.60	3.70	3.80
Contact Width	b	0.15	0.20	0.25
Contact Length	L	0.30	0.40	0.50
Contact-to-Exposed Pad	K	0.20	-	-
